Cashiers, North Carolina Stormwater Study and Flooding Recommendations

A Capstone Design Project Report

Renovatus Solutions
Georgia Institute of Technology
790 Atlantic Drive
30332

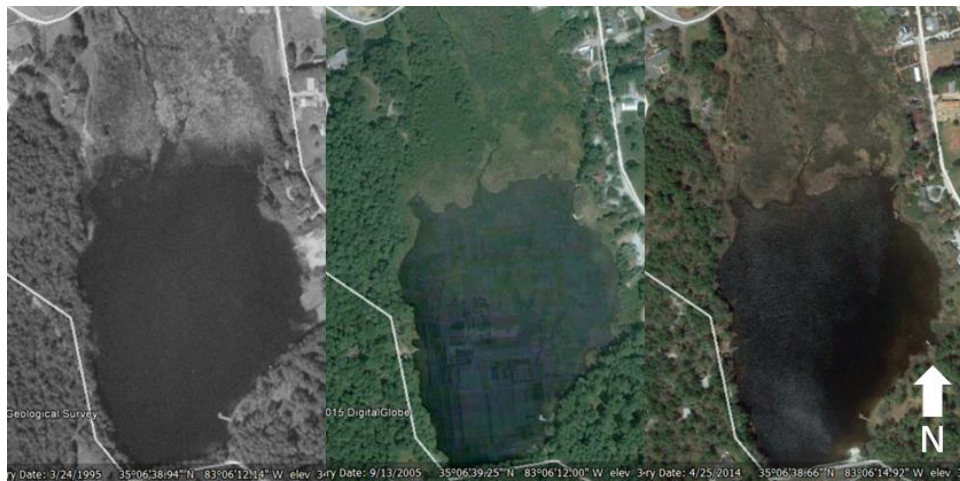
Figure 3. Wetland area increase. Aerial View of Cashiers Lake and wetland area in 1995, 2005, and 2014 (left to right)

The wetland area north of Cashiers Lake and directly south of Frank Allen Road have accumulated sediments over time. The accumulation has led to the expansion of the wetland area as seen in Figure 3 below. This sedimentation impedes the flow of stormwater into Cashiers Lake. In addition to the sedimentation, the soil characteristics also impedes flow through the wetland area. The Cashiers Creek Wetland is made up of Nikwasi soil which is a poorly drained soil. The soil retains large amounts of water, obstructing flow downstream. Sediment accumulation, along with Nikwasi soil, can be attributed to high volume of sediments upstream of the wetland area.

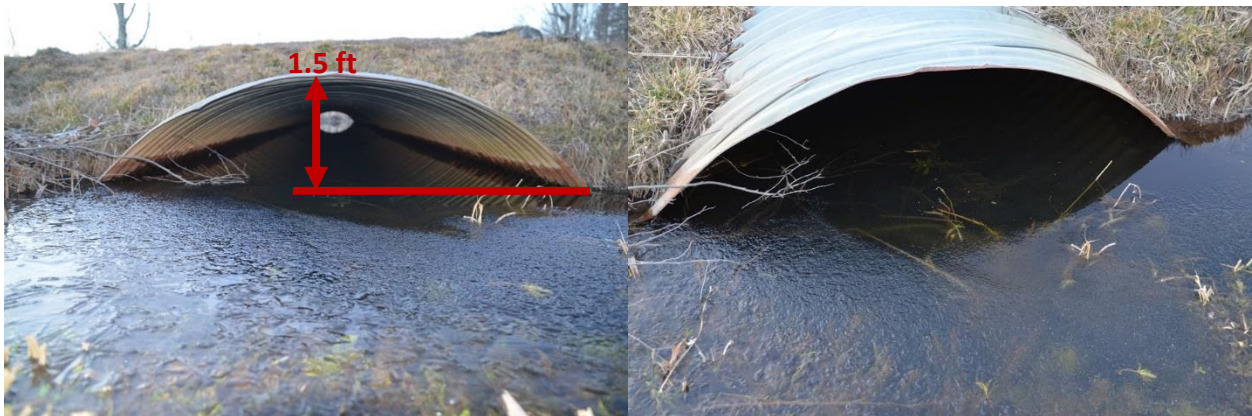
Figure 6. Frank Allen Rd Double Culverts (one culvert from two different angles). For a sense of scale, the culverts are approximately five feet in height. In addition to the high water level, there were many aquatic plants growing near the culvert inlets.

The high water level in the culverts is believed to be due to a high water table in the area. Evidence of this was found in a depression in the ground surface nearby (Figure 7). This depression is located east of the culverts about 150 feet away. The water surface of this ponding was not connected to the water surface of the stream leading to the Frank Allen culverts. This ponding, along with the fact that it had not rained recently, indicates a high water table in the area.

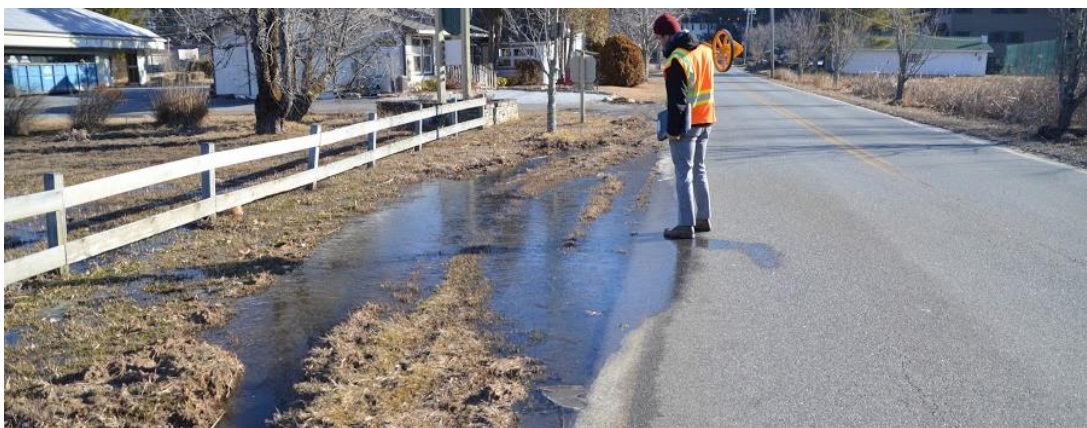
Figure 7. Ponding Along Frank Allen Rd. About 150 ft east of the Frank Allen Rd culverts, the ponding water surface is not connected to the standing water at the culverts.

In addition to the evidence of a high water table, signs of past flood events were visible at Frank Allen Rd. Erosion of the road shoulder material within the area of ponding was observed. This type of erosion was not found in areas without ponding. It is possible that this erosion was caused by water scouring away at the roadbed during flood events. Furthermore, ponding in this location can be seen in Google Maps (Figure 8) on multiple occasions, indicating that this ponding is a recurring phenomenon.

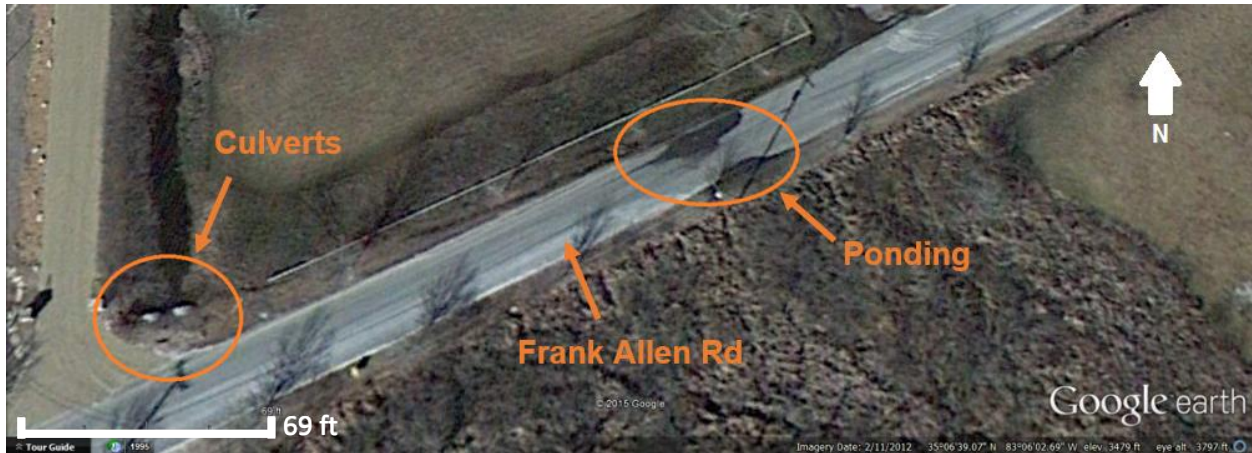
Figure 8. 2012 Frank Allen Rd Ponding. Google Earth image showing ponding along Frank Allen Rd in relation to the Frank Allen Rd culverts. Scale bar is located in bottom left.

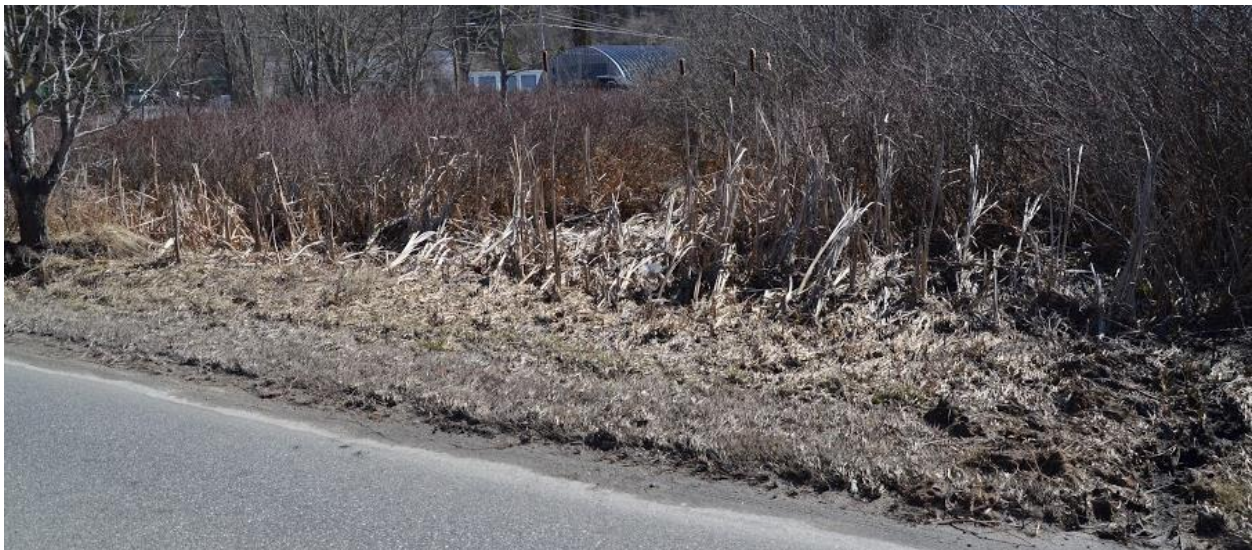
Figure 9. Evidence of Overtopping of Frank Allen Rd. Flatted plant vegetation as evidence of past high water flow conditions. Photo taken on Frank Allen Rd, facing southeast.

Further evidence of past water flow over Frank Allen Road was observed across the road from the ponding. Vegetation on this side of the road was bent and flattened towards the south in the same direction that water would flow over the road (Figure 9).

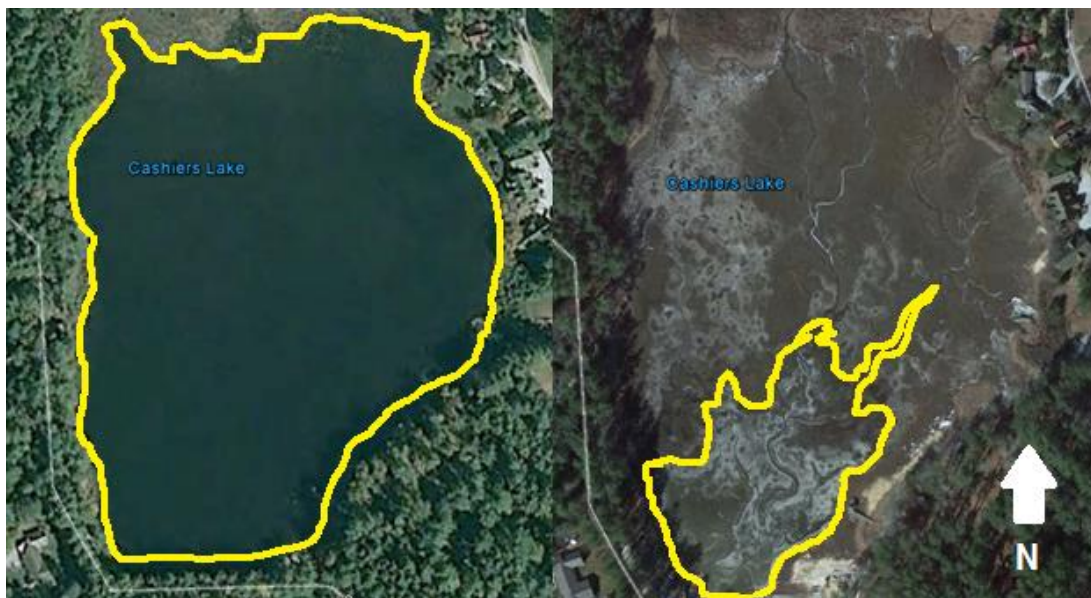
Figure 10. Cashiers Lake Water Surface Before and After Draw Down. The left image is dated 5/30/2009 (before dam remediation), and the right image is dated 2/11/2012 (during dam remediation).

- 1) **Flooding at the Frank Allen Rd culverts has been decoupled from the water level of Cashiers Lake.** During the initial stages of this study, we believed that the flooding issues were related to the downstream reservoir increasing the local water table. However, Cashiers Lake has been drawn down four feet for remediation on the dam embankment during the winter of 2011-2012 (Figure 10). A reduction in flooding events as well as standing water at the Frank Allen Rd. culverts was not apparent to observers during the time that the reservoir had been drawn down. If the high water table in the Frank Allen Rd. culverts is being caused by the presence of the Cashiers Lake Dam downstream, a decrease in the water level of the culverts during the time that the reservoir was drawn down would be expected. The fact that no documented decrease occurs suggests that the high water table is not directly caused by the level of the reservoir.

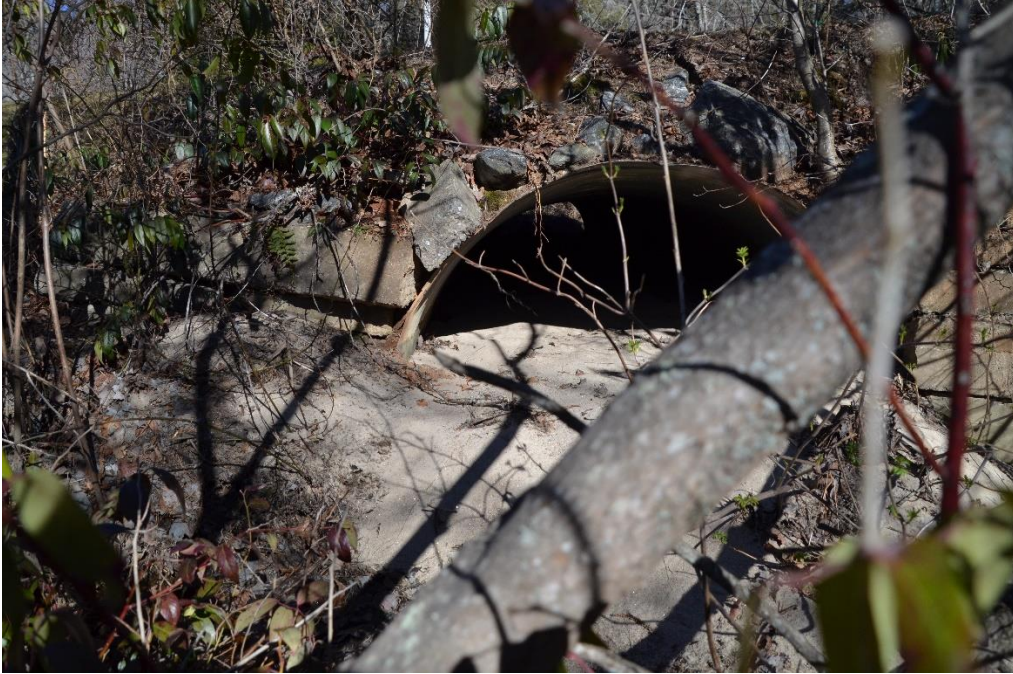
Figure 13. Sedimentation where Cashiers Creek enters under US-64

- a) **Cashiers Creek:** Cashiers Creek flows through a high elevation region towards the entry point at US-64 and slows down rapidly. The drop in elevation before the entry point is around 20 feet over a stretch of 0.2 miles (1056 feet) which gives a slope of 0.019 ft./ft. whereas the drop in elevation after the entry point is about 6 feet over the same length which gives a slope of 0.0057 ft./ft. We can see that the region within the flood impact zone is not very steep. Figure 13 is a picture taken at the entry point of Cashiers Creek where sedimentation in one of the culvert is highly noticeable.

The sedimentation at the entry point is most likely due to the steep drop in elevation (approaching US-64) which causes the sediments to be transported rapidly and as the elevation gradient gets smaller (after the entry point), the flow slows down depositing large amount of sediments at that point.

The west point of entry of Cashiers Creek at US-64 as shown in Figure 13 brings a lot of sediments from higher elevation region. The drop in elevation before the entry point is around 20 feet over a stretch of 0.2 miles (1056 feet) which gives a slope of 0.019 ft./ft. whereas the drop in elevation after the entry point is about 6 feet over the same length which gives a slope of 0.0057 ft./ft. This rapid change in slope causes most of the sediments to deposit on the entry point by US-64. As Cashiers Creek flows downstream a lot of the heavier sediments are left behind. A sample collected near the Trail Bridge on Cashiers Creek had an average particle diameter of 0.93 mm.

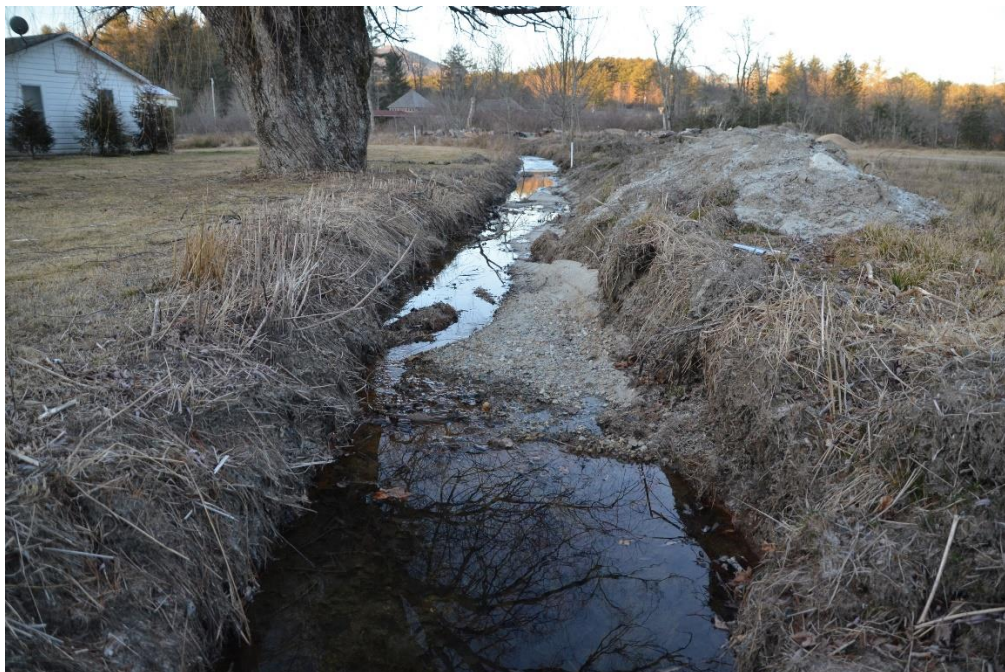
Figure 14. Ditch 3, along with its large amount of sediment deposition

Cashiers Creek, as it continues downstream, combines with Ditch 1, Ditch 2, and Ditch 3, carrying along with it a certain amount of sediment. Ditch 1, Ditch 2 and Ditch 3 also bring large amount of sediments as can be seen in the Figure 14 and Figure 15 below.

- d) **Ditch 3:** This stream, as shown in Figure 12 above transports water from Burns St. and its surrounding, and directs the flow into Cashiers Creek. This stream also carries a lot of sediments into Cashiers Creek as shown in Figure 14 above. Most of the sediments look like they were remnants of what had been dug out to during the construction of this stream.

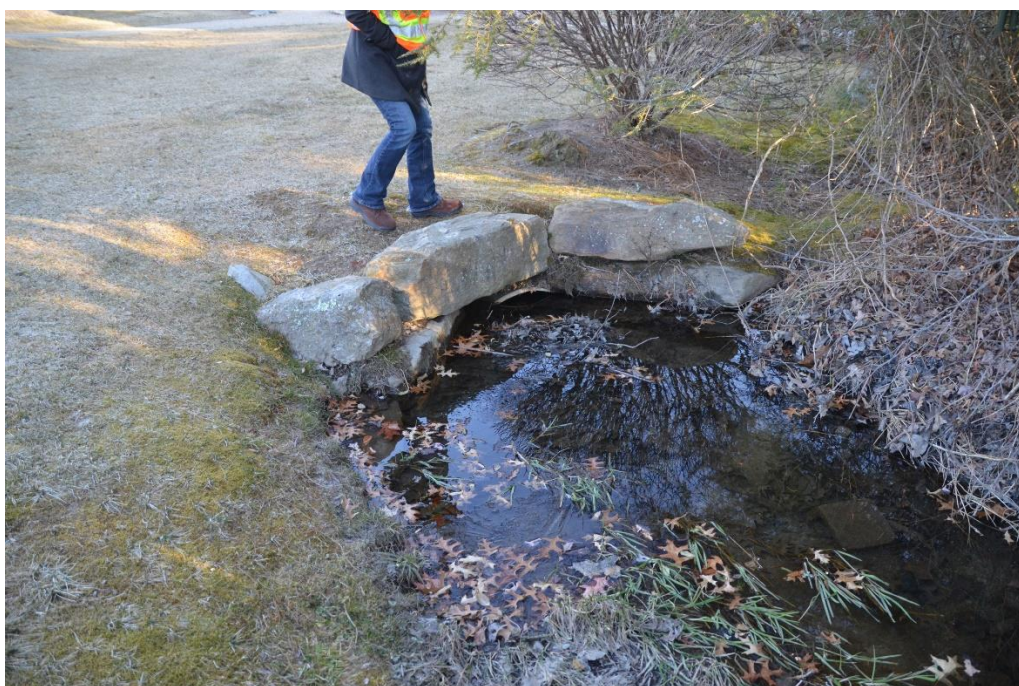
Figure 15. Mouth of culvert connecting Ditch 1 and Ditch 2, after it branches from Ditch 1.

- c) **Ditch 2:** As shown in Figure 15 above, the standing water is caused by the heavy sedimentation as well as the presence of vegetation in the stream. The sediments of this stream are not only a result of Ditch 1, but also the playground parking lot. Figure 17 is a picture of Ditch 2 runoff after a rainfall. The muddy water shows the sediment that is being carried by this stream; an extended analysis on sediment size distribution found at various parts of streams in section 4.1.2

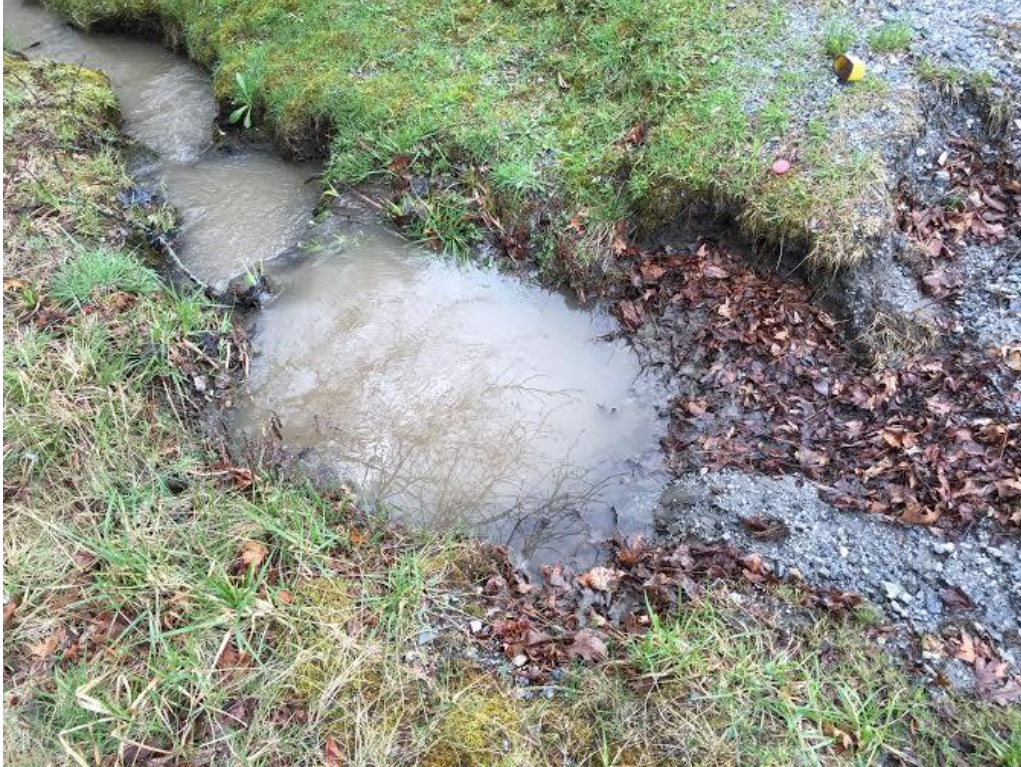
Figure 16. Ditch 1 by US-64 beside the road.

- b) **Ditch 1:** This stream originates from the various runoff on the north east side of US-64. This stream also directs the water towards Cashiers Creek from various catch-basin and surface runoff on US-64. Figure 16 shows the starting point of Ditch 1 right beside the highway.

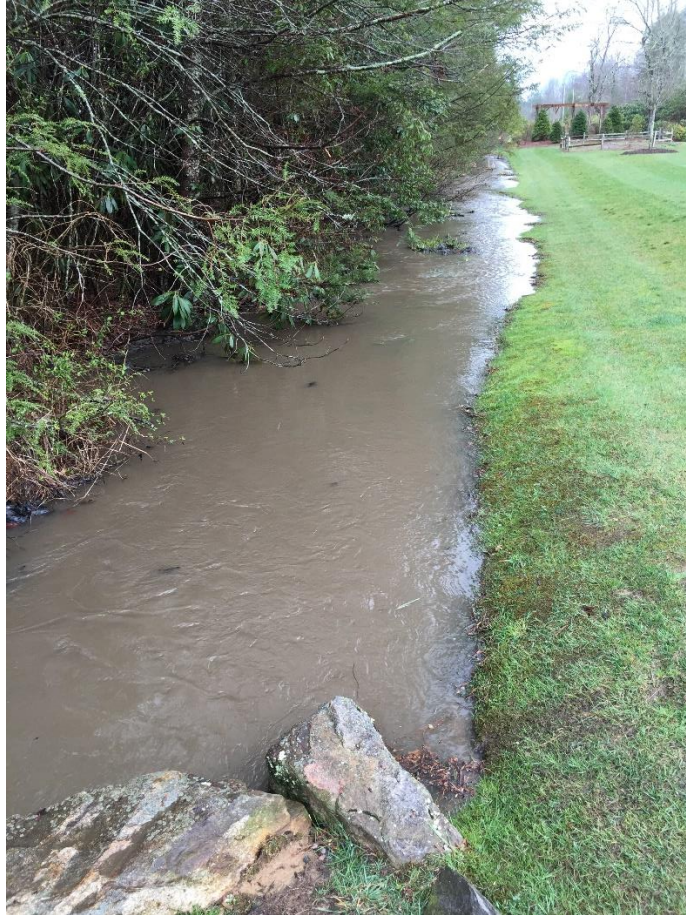
Figure 17. Ditch 2, view is facing downstream towards Cashiers Creek

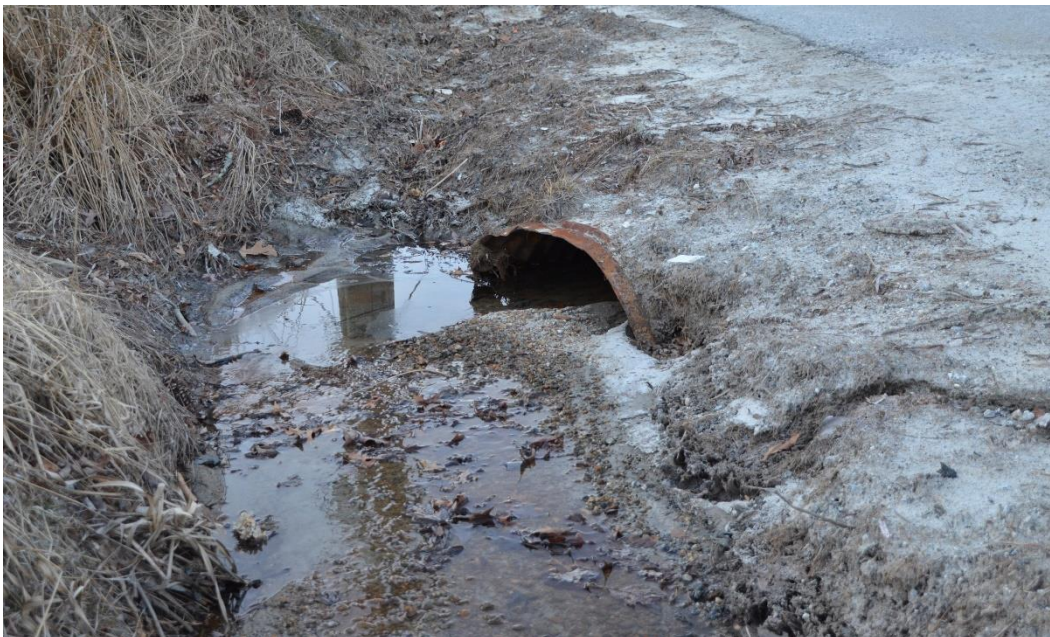
Figure 20. Inlet of culvert 3, with heavy sedimentation.

- d. **Culvert 3:** Located to the east of Cashiers Creek, this culvert runs under Burns St in and connects water directed towards Ditch 3. This culvert has a high load of sediment, which can be seen in the Figure 20 below.

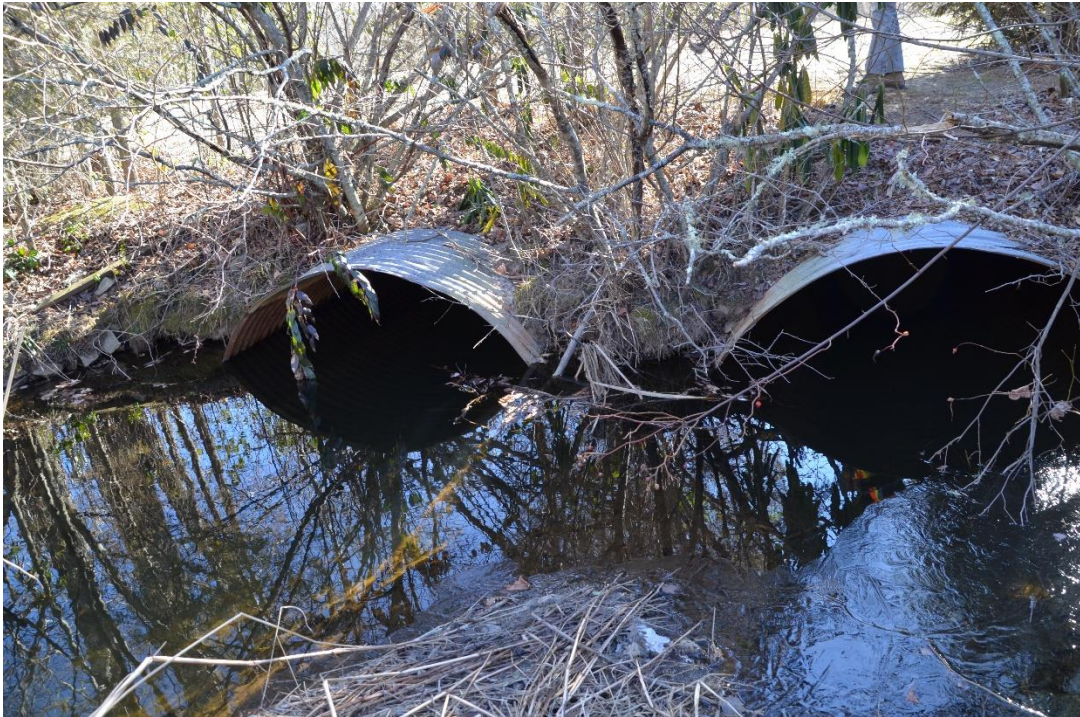
Figure 21. Culvert Set 2 connecting east-side water into Cashiers Creek.

- e. **Culvert Set 2:** These culverts are another set of Arch CMP with the same dimensions as Culvert 6. These culverts connect Cashiers Creek with Ditch 1. All of this flow is conveyed to a point north of Frank Allen Rd. A picture of Culvert Set 2 is shown in Figure 21 below.

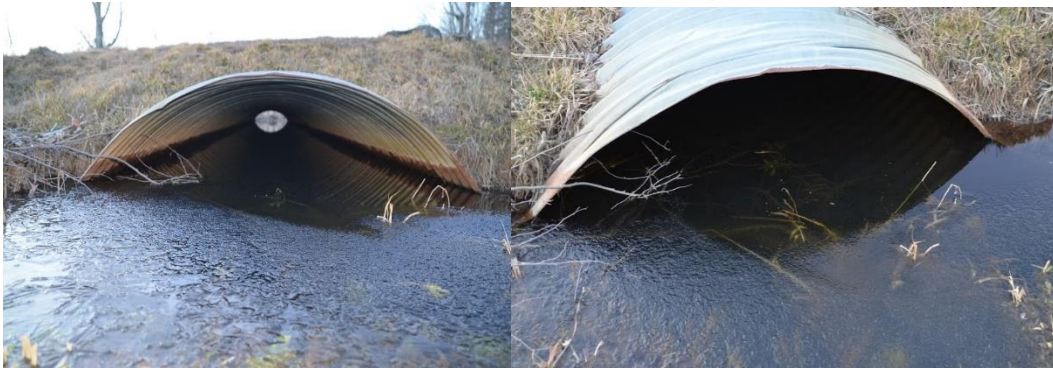
Figure 22. Culvert Set 1 right below Frank Allen Rd.

- f. **Culvert Set 1:** These culverts serve as the outlet of our watershed. These culverts convey all the flow from the north of Frank Allen Road into Cashiers Lake Wetlands. These culverts have the same specification as that of Culvert 2 and 6 (Arch CMP 81"×59") as shown in Figure 22 below.

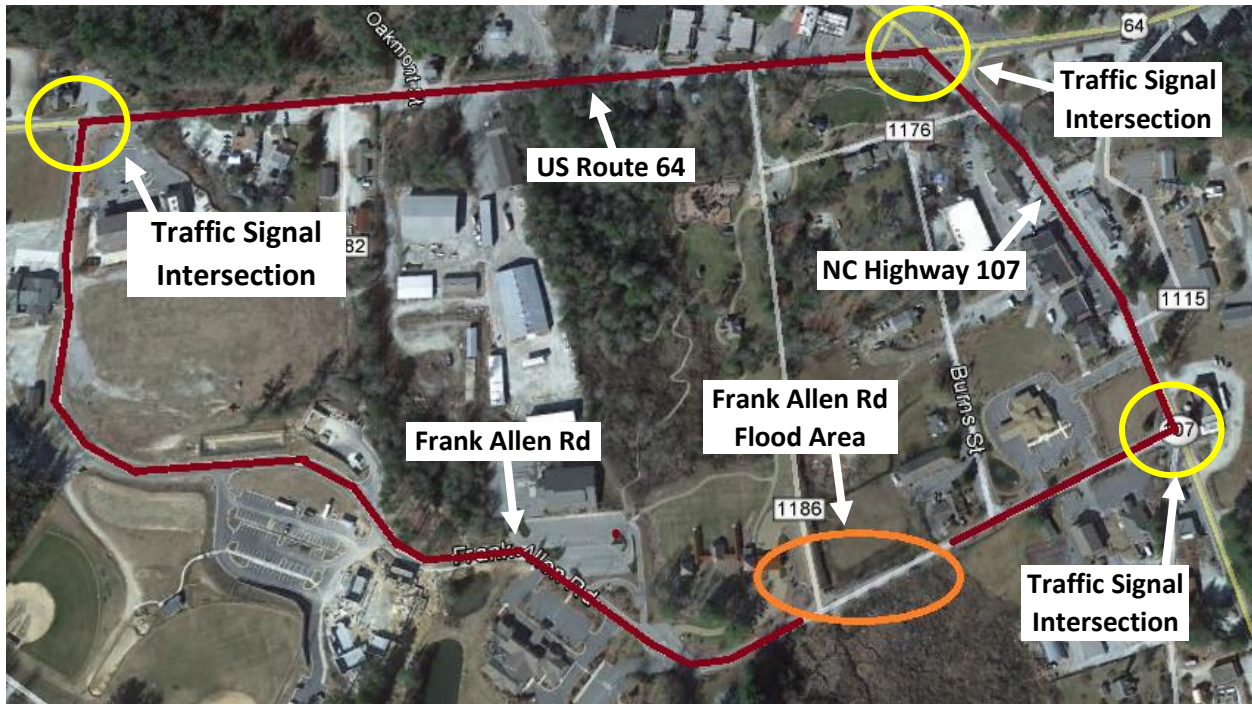
Figure 37. Frank Allen Rd Detour Route. The orange circle highlights the portion of Frank Allen Rd that would be affected by flooding and the high water table. The dark red line indicates the proposed detour that would allow access to both sides of Frank Allen Rd unaffected by flooding. The yellow circles outline traffic signal intersections.

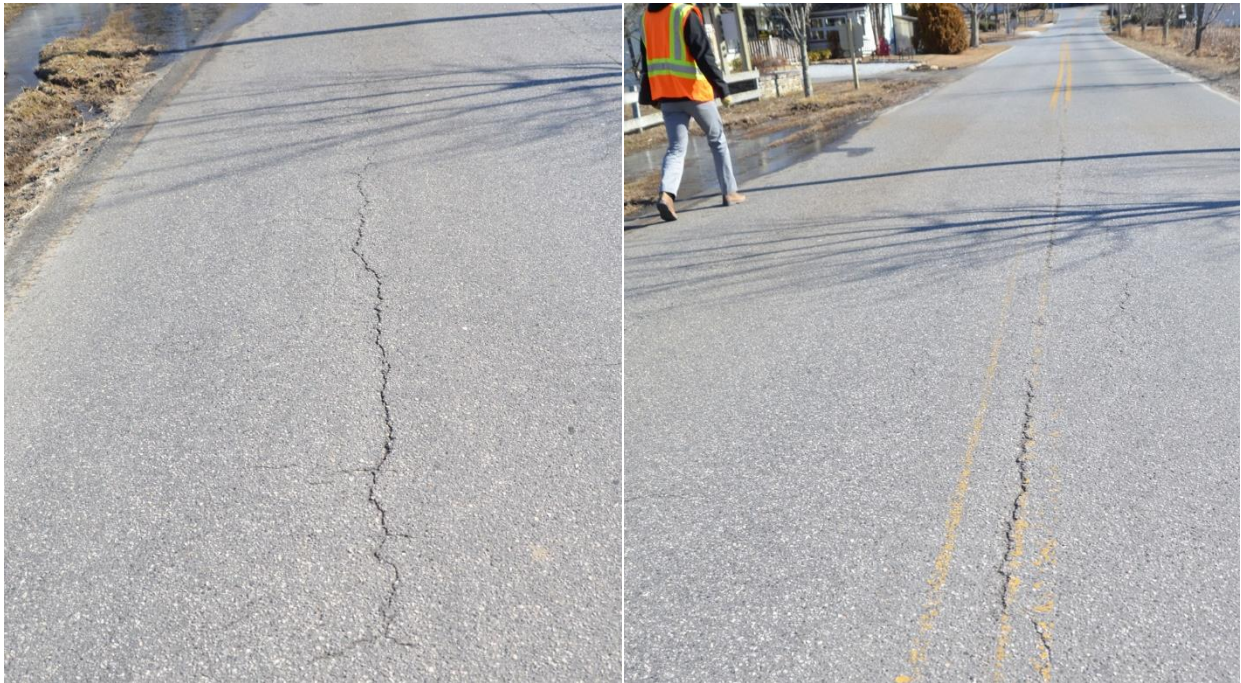
Figure 38. Frank Allen Rd Longitudinal Cracks. Left photo shows a crack in the center of the lane, outside of the wheel-path. Right photo shows a crack along the lane striping, outside of the wheel-path. Average crack width < 0.5 inches.

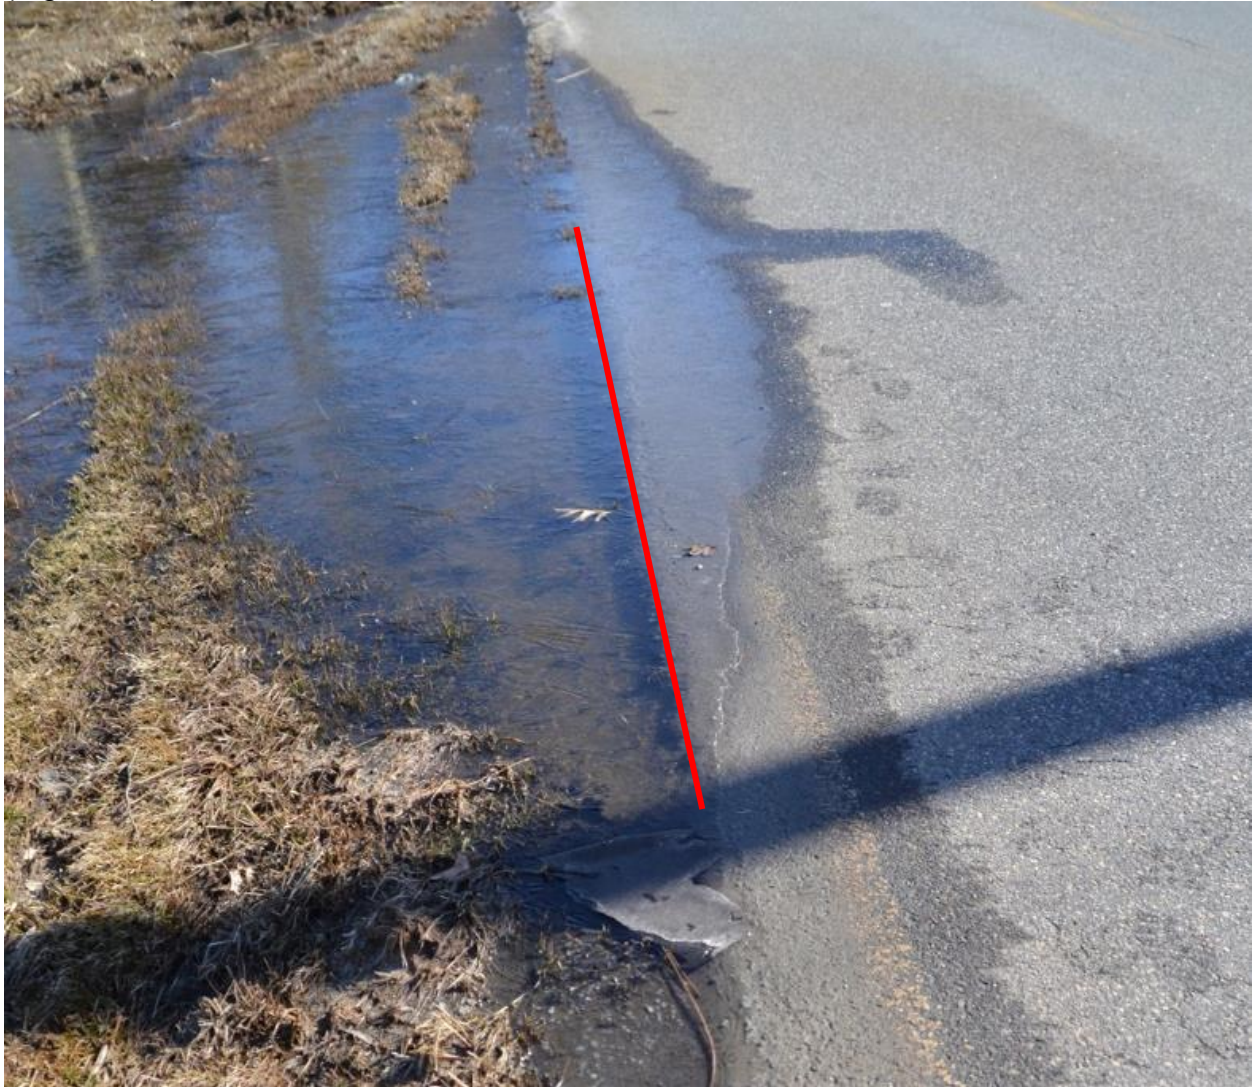
Figure 40. Frank Allen Rd Road Shoulder Material Scour highlighted by the red line, approximately 20 feet in length. Scoured area appears as shadow to the left of the red line.

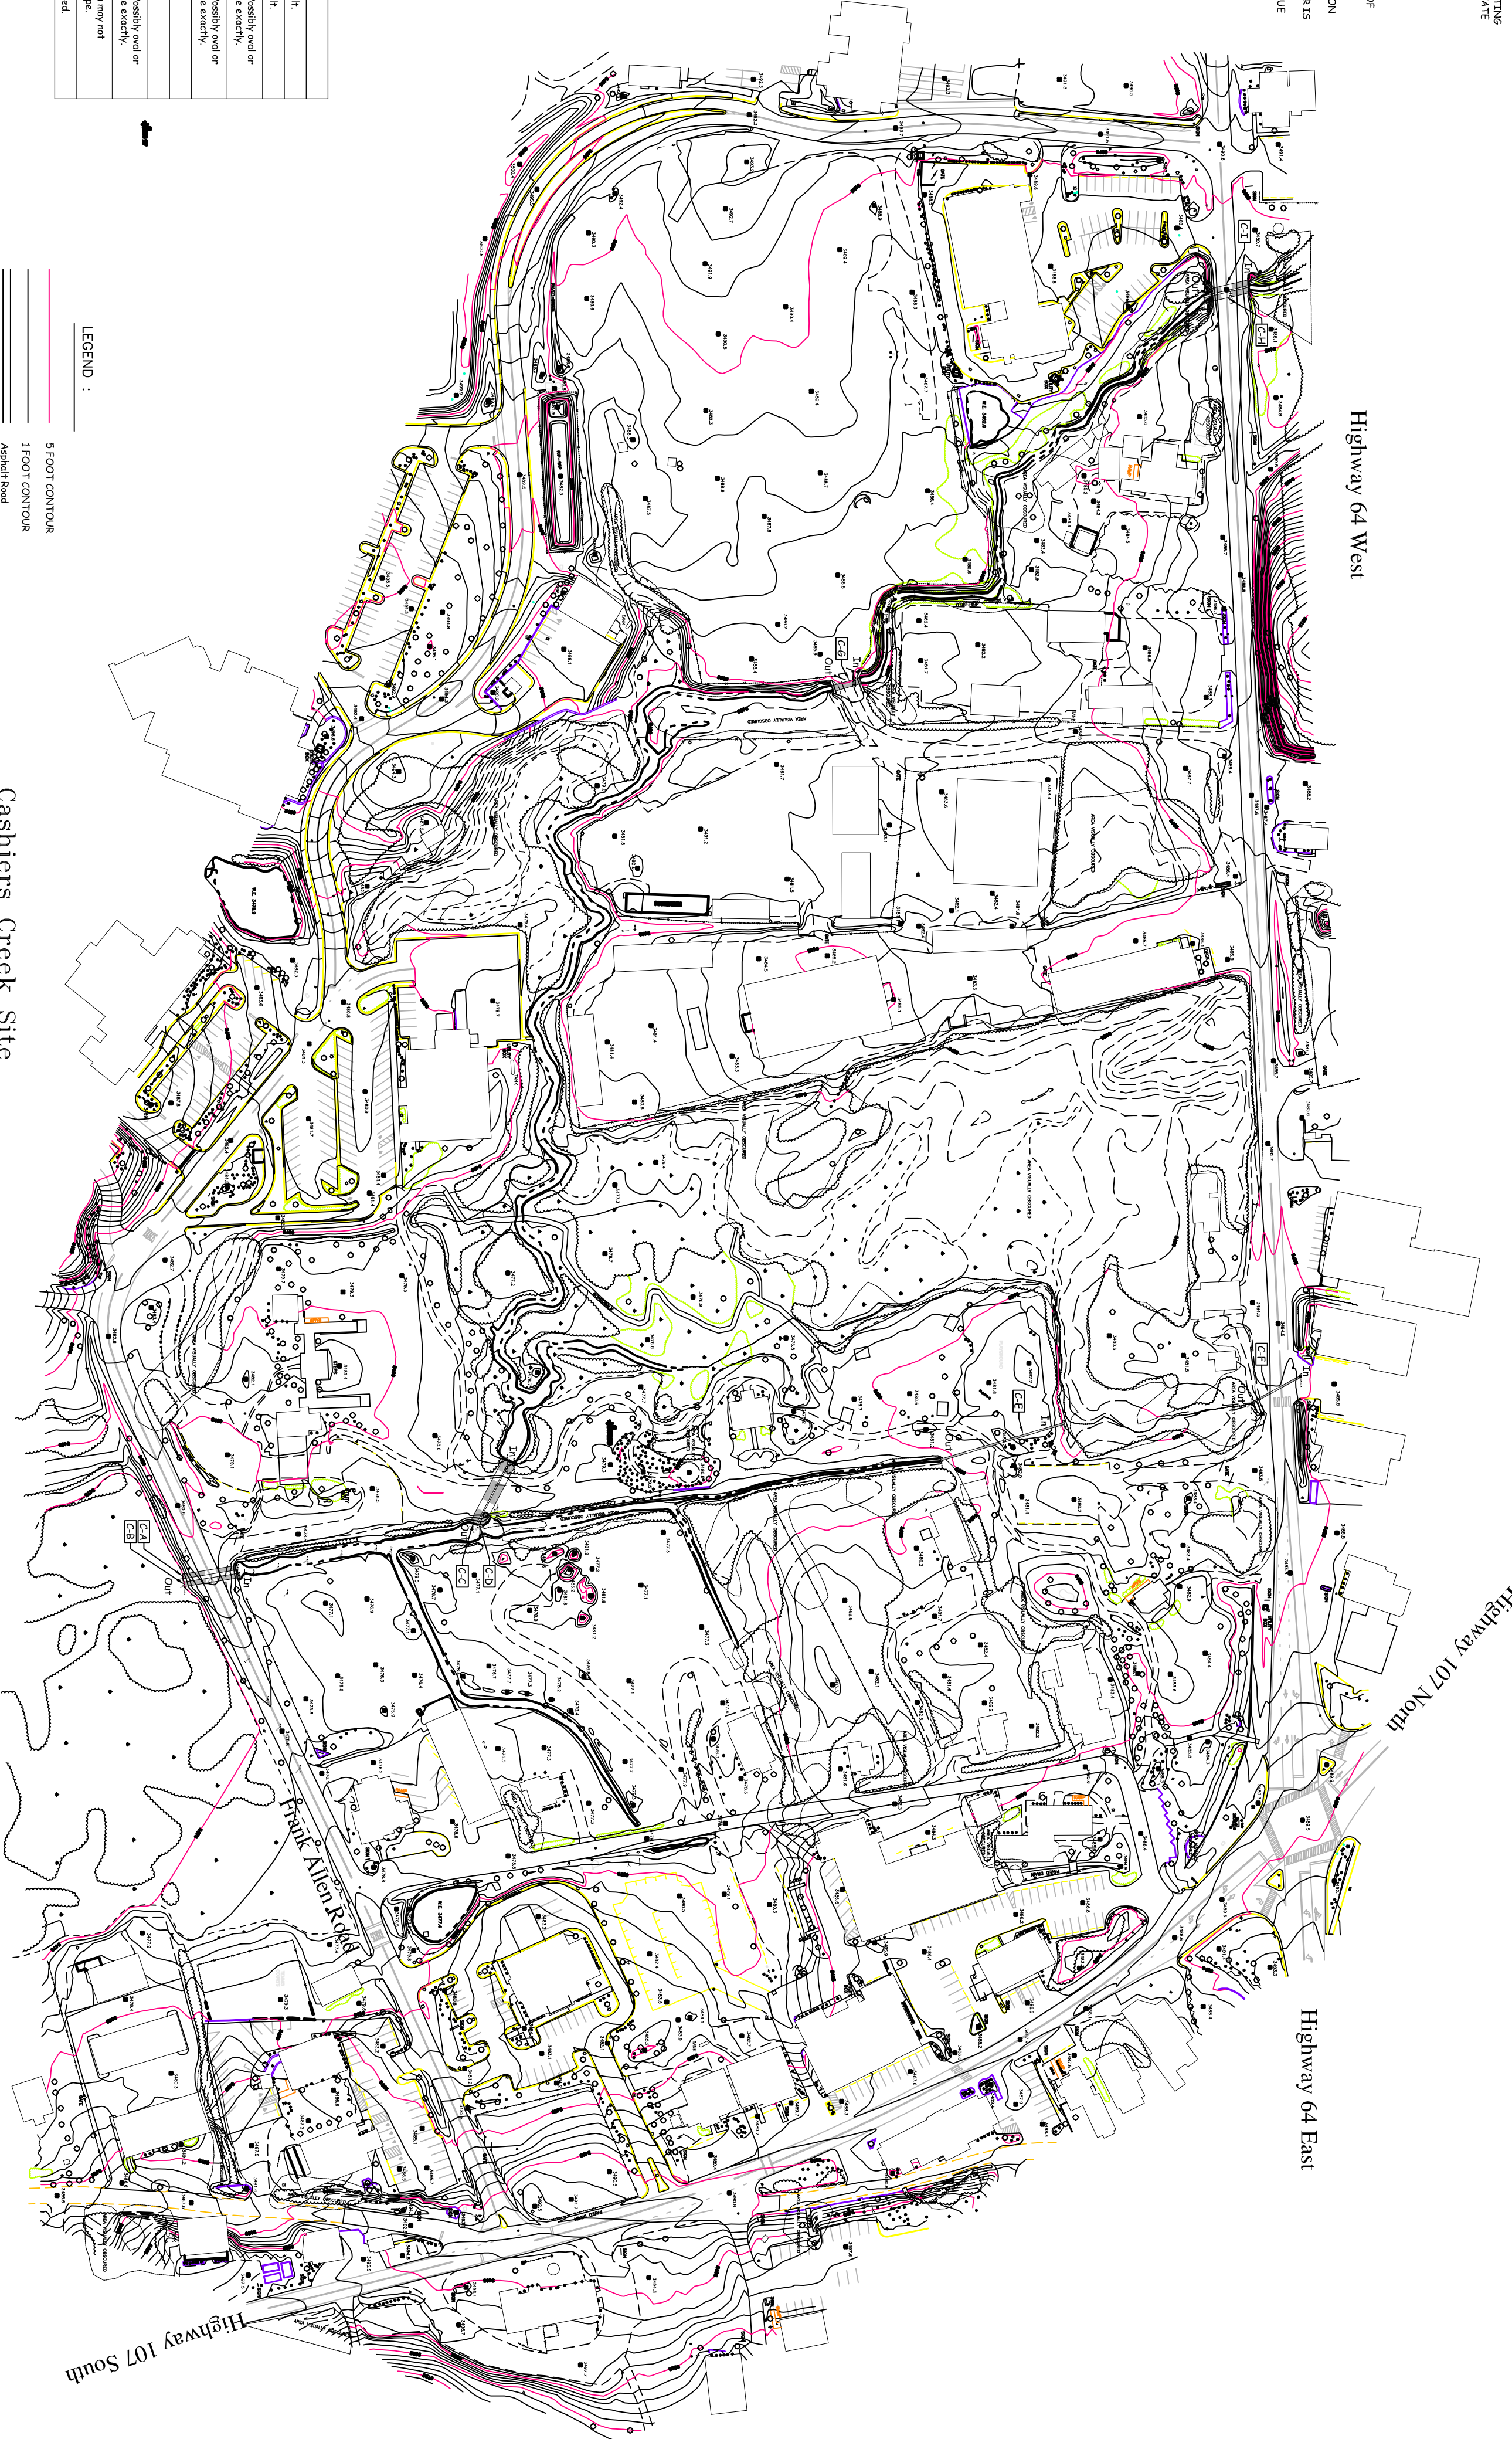
Cashiers Creek Site

Cashiers Lake elevations at the dam.

Point	Northing	Easting	Elev.	Description
100	518487.84	773982.53	3471.32	WATER LEVEL
101	518480.53	773033.91	3470.24	CHANNEL BOTTOM
103	518485.23	773671.82	3471.26	RISER TOP
